FA8903-08-D-8786 TO 0011		North Wind, Inc		Title II Oversight Hill AFB Housing Area PCB Remediation OU 13	
Project Number: KRSM20110835		(Remediation Contr is Cape)			
Contract Number / Task Order Number		Contractor		Project Title / NWI Project No.	
1		04/07/11		Hill AFB, UT Freedom Terrace Housing Area OU-13	
CQC Report Number		Date or Time Period		Location and Team

Hill AFB Housing area OU-13. PCB excavation areas marked at 4111 B North Bridge Circle

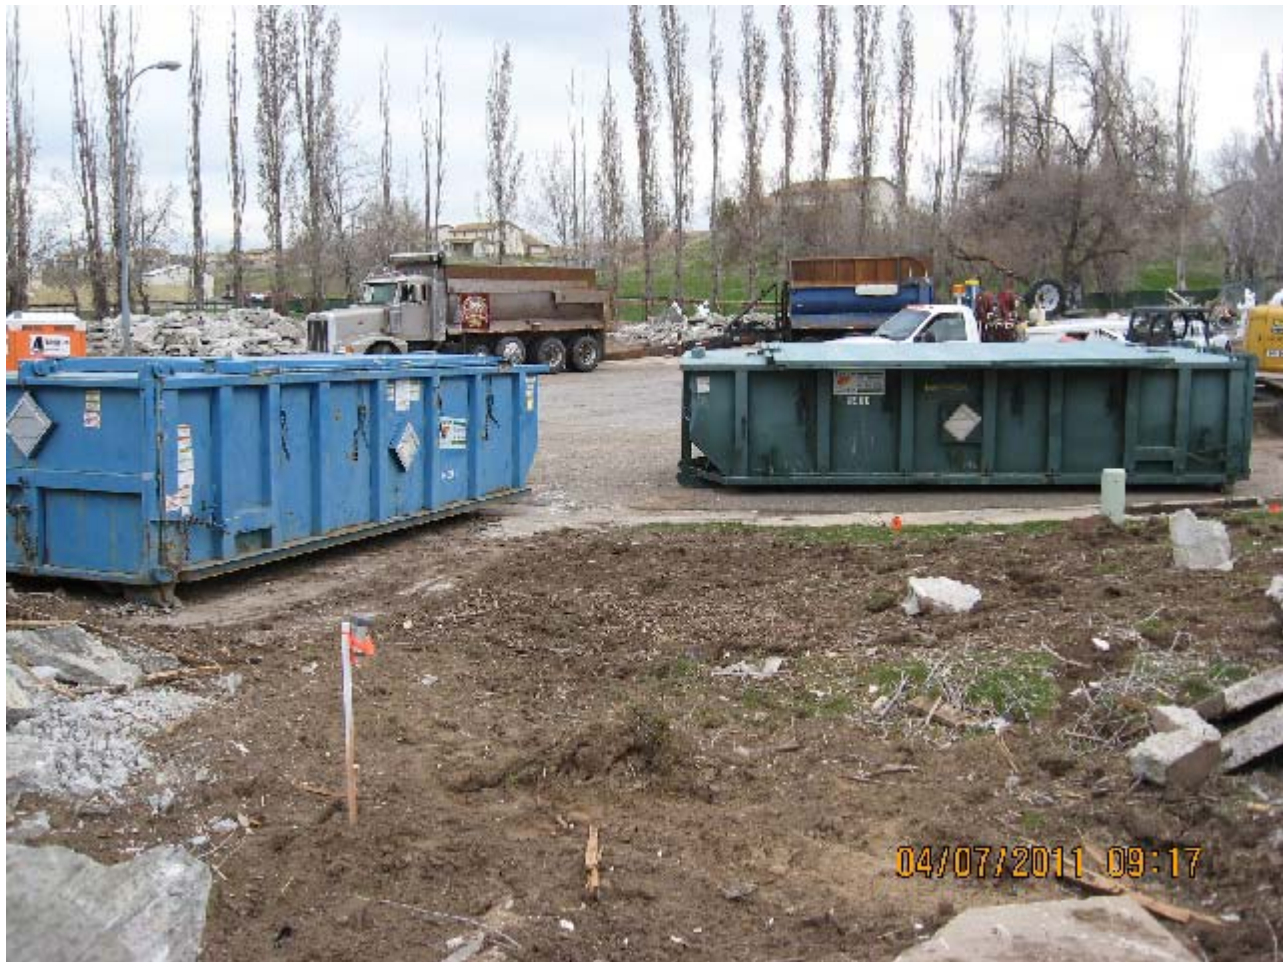
Date	Time	Direction of View
04-07-11	0917	North

Hill AFB Housing area OU-13. PCB roll-off boxes staged at 4111 B North Bridge Circle prior to beginning excavation.

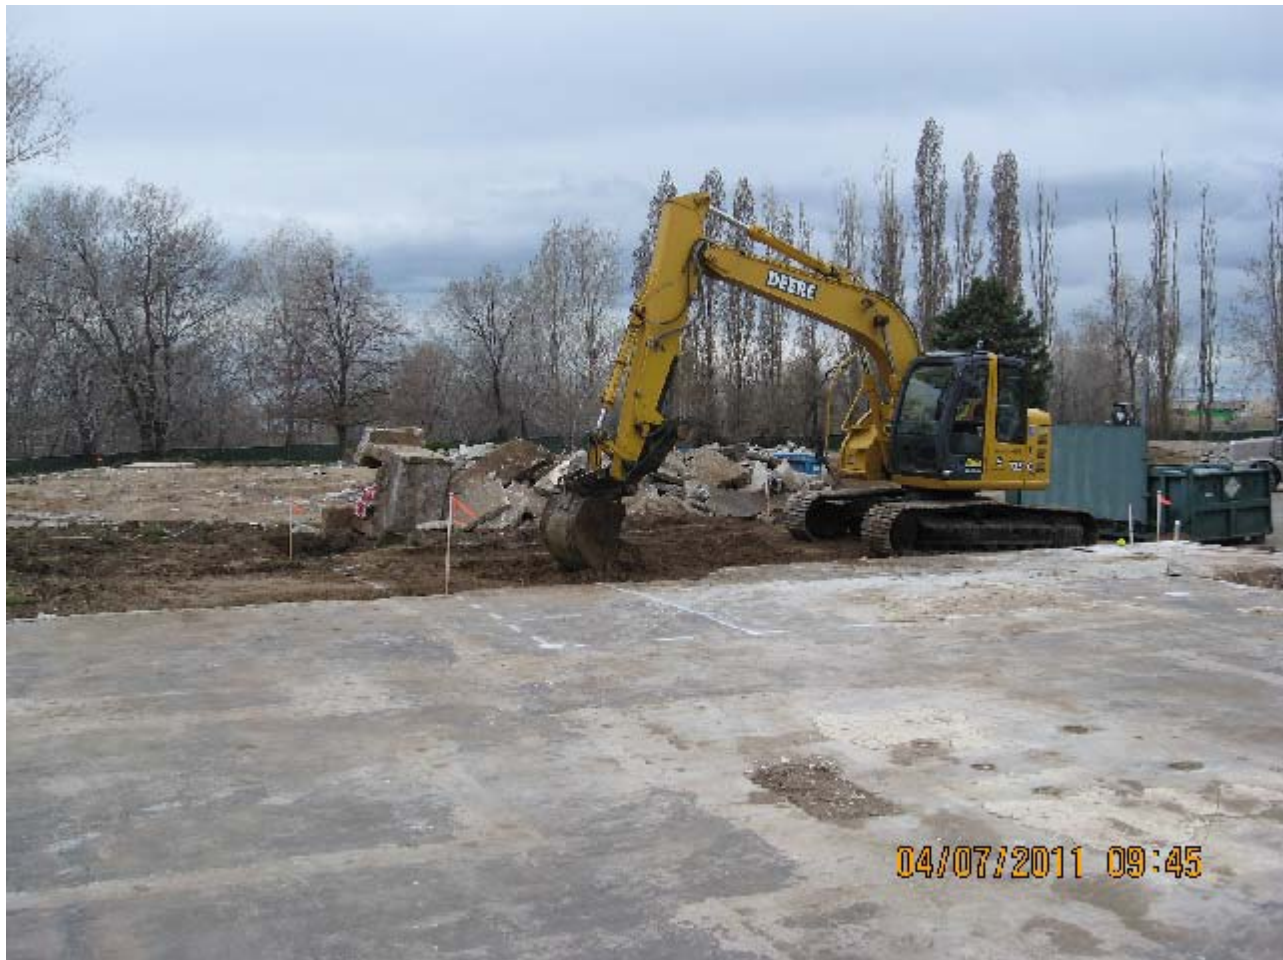
Date	Time	Direction of View
04-07-11	0945	NW

Hill AFB Housing area OU-13. Beginning excavation at 4111 B North Bridge Circle.

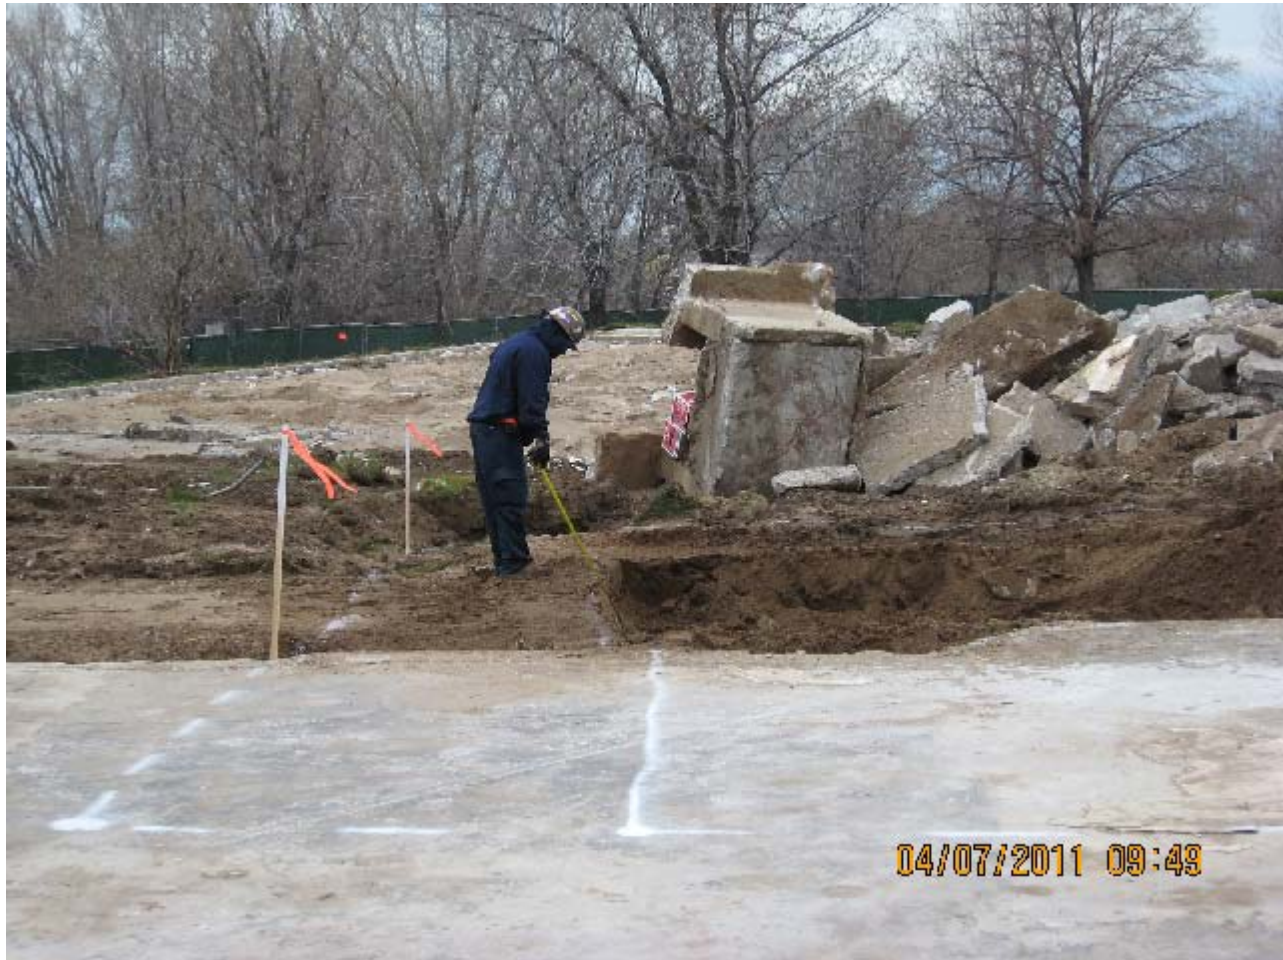
Date	Time	Direction of View
04-07-11	0949	NW

Hill AFB Housing area OU-13. Measuring depth of excavation at 4111 B North Bridge Circle.

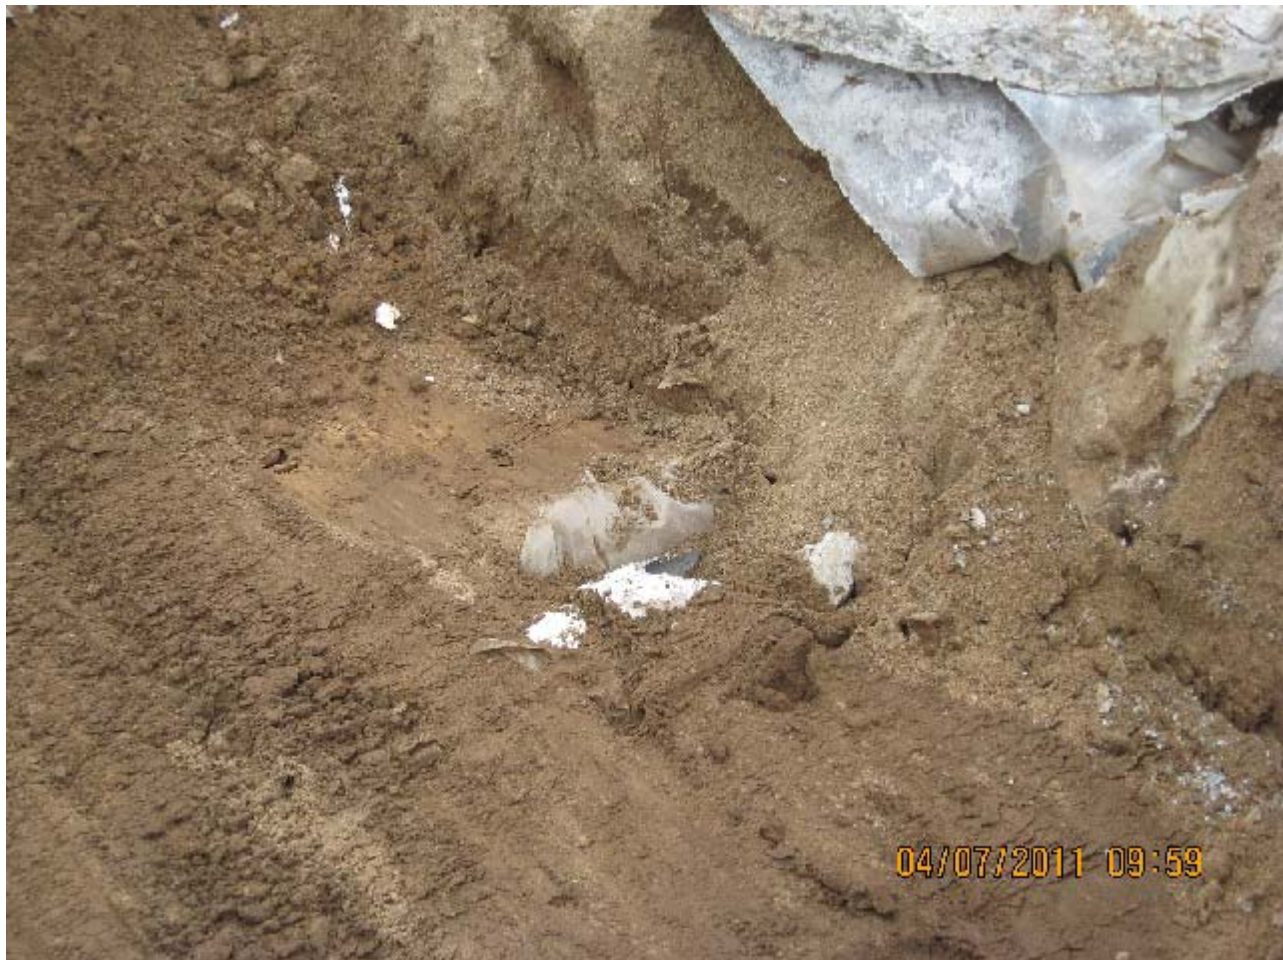
Date	Time	Direction of View
04-07-11	0959	NE

Found one piece of transite pipe about 1.5 feet long (HVAC ducting common to these houses) at about 2ft depth. Wetted transite, placed in plastic bag. The ACM abatement crew working across the street took the material.

Hill AFB Housing area OU-13. Transite pipe at about 2 ft depth in excavation at 4111 B North Bridge Circle. This is a piece of the HVAC ducting common to these houses.

0940
FOUND A PIECE OF TRANSITE PIPE
AT ABOUT 2 FT IN SOUTH PART OF DUC -
WATERED IT, BROKE IT - GAVE IT TO ACM
GUY'S ACROSS THE ST.

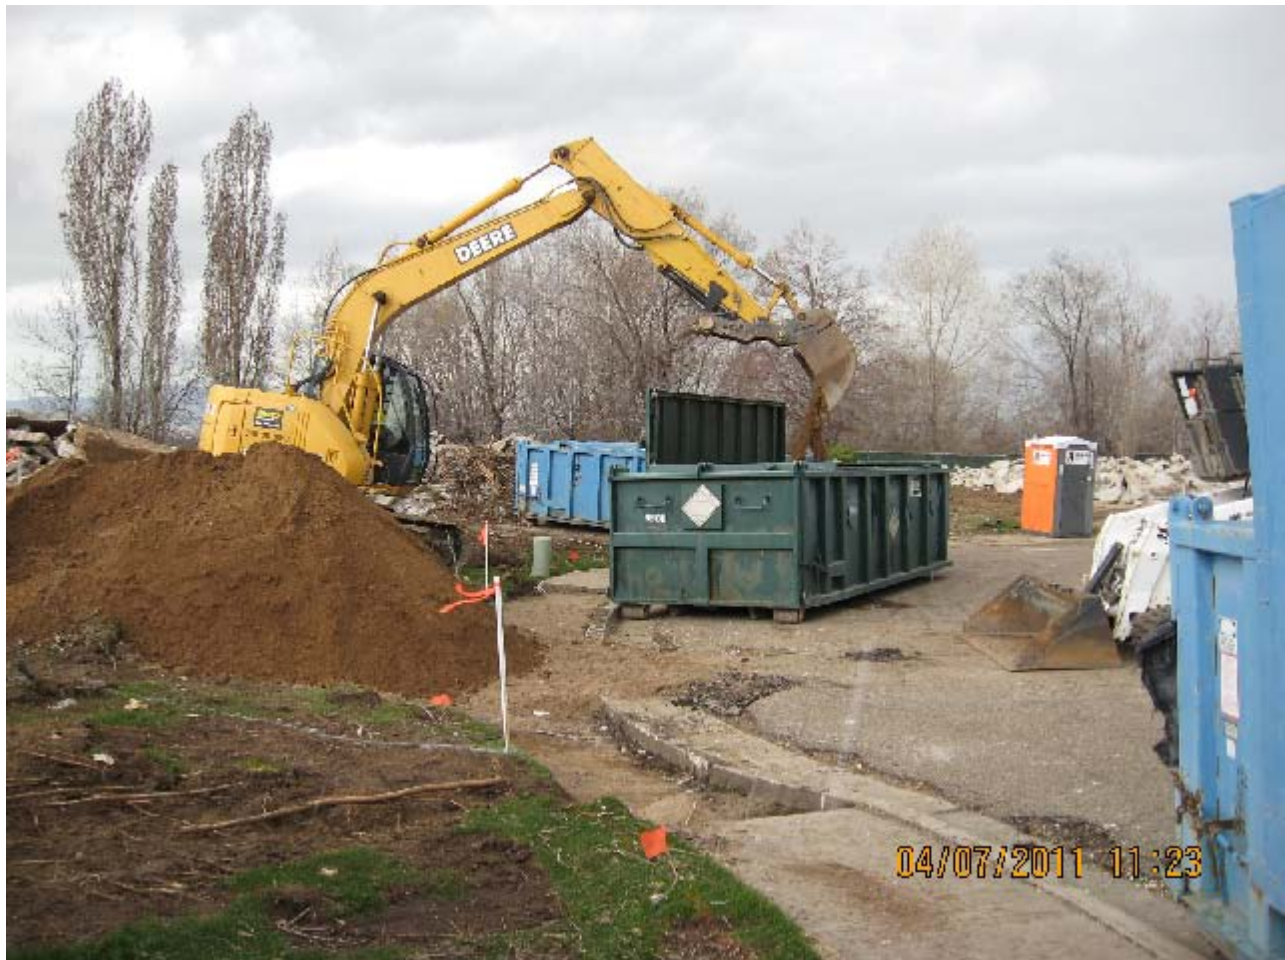
Date	Time	Direction of View
04-07-11	1123	W

Hill AFB Housing area OU-13. Placing TSCA regulated soil into roll-off box at 4111 B North Bridge Circle.

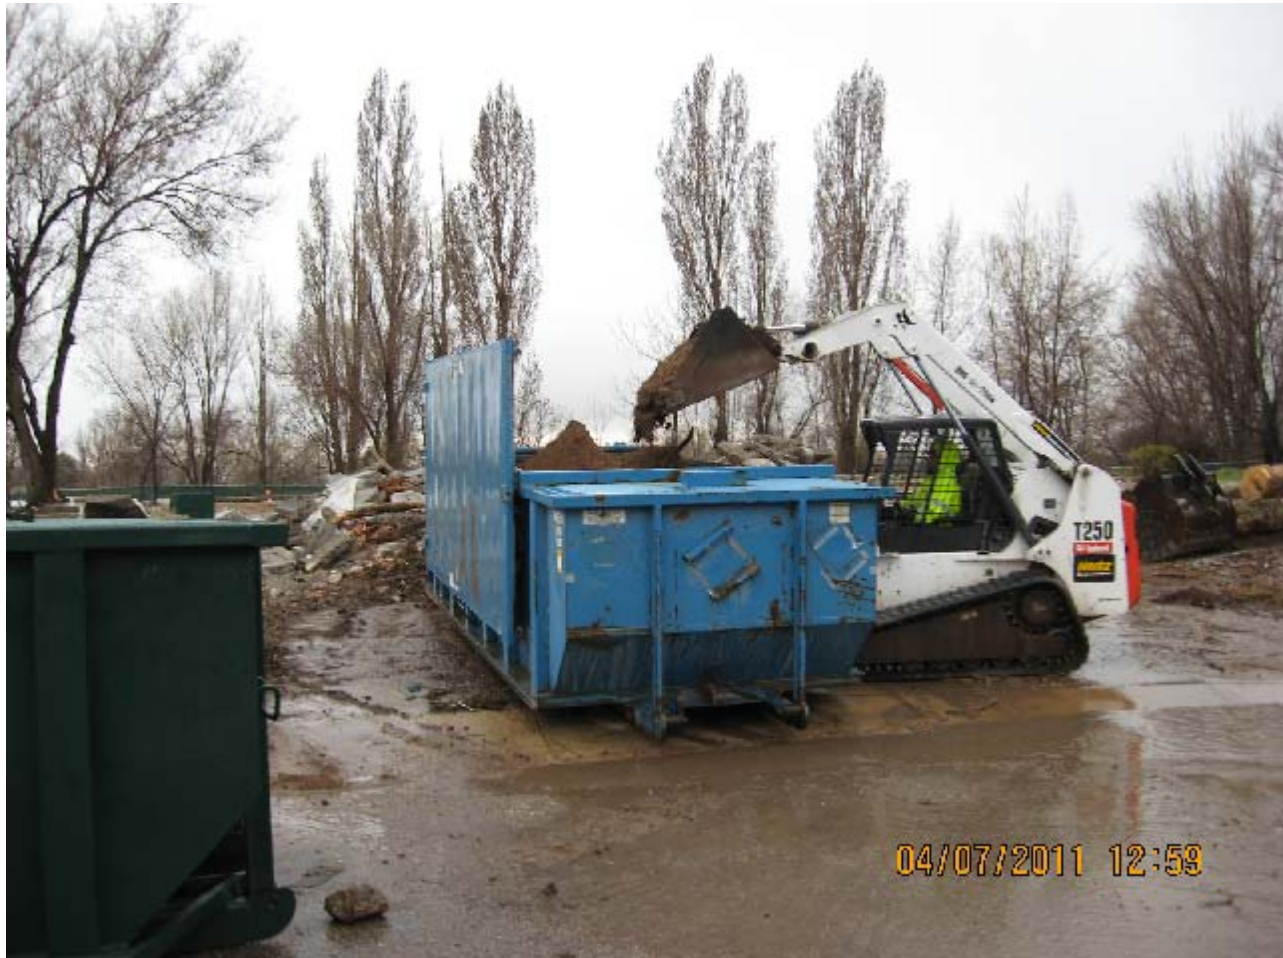
Date	Time	Direction of View
04-07-11	1259	W

Hill AFB Housing area OU-13. Using Bobcat to Place TSCA regulated soil into roll-off box at 4111 B North Bridge Circle.

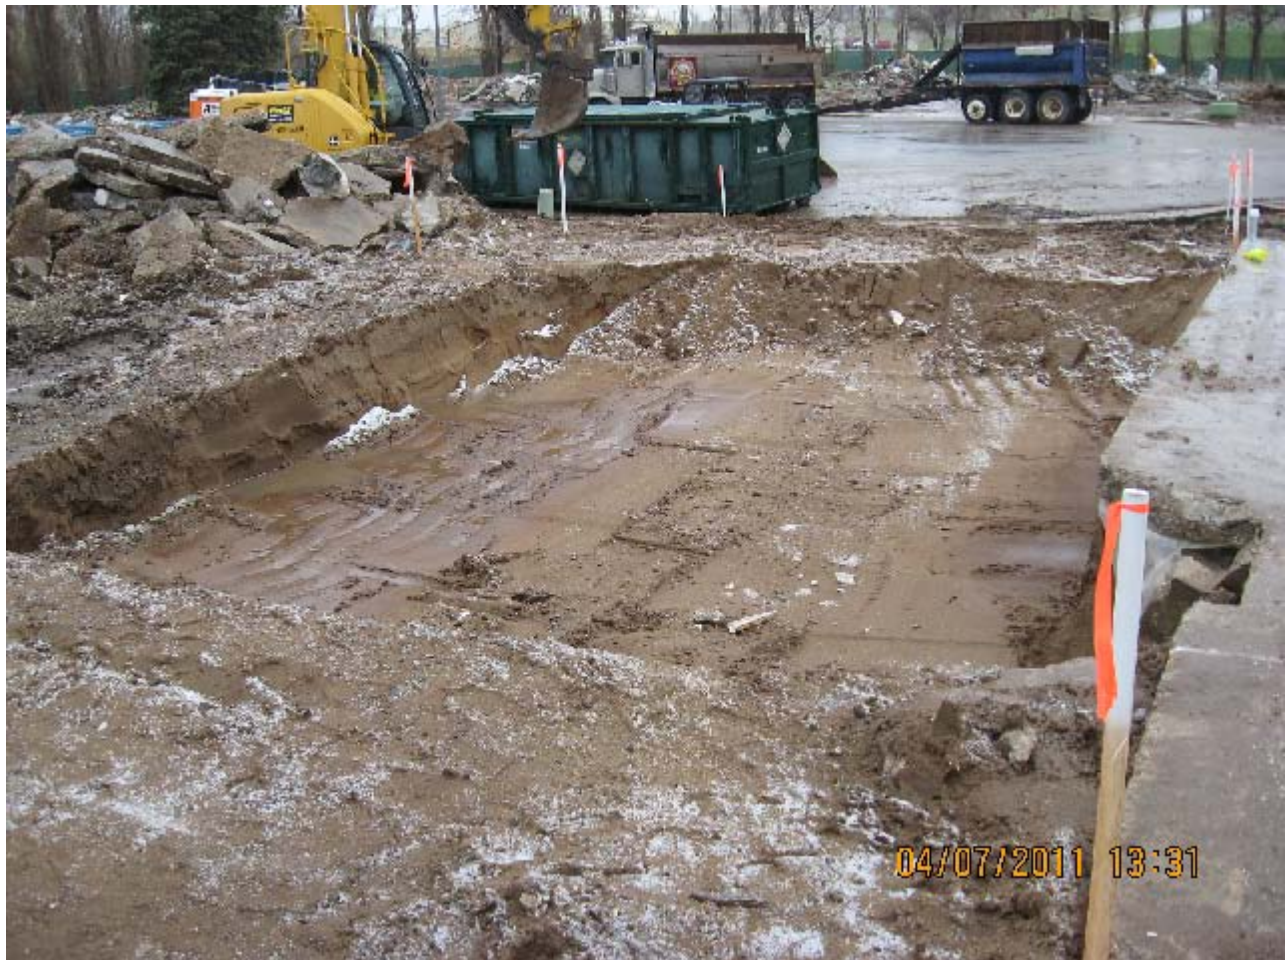
Date	Time	Direction of View
04-07-11	1331	N

Excavated to two feet depth in both areas where PCB concentrations exceeded TSCA limit of 50 mg/kg at 4111 B North Bridge Circle.

Hill AFB Housing area OU-13. Excavated to 2 ft to remove TSCA regulated soil at 4111 B North Bridge Circle.

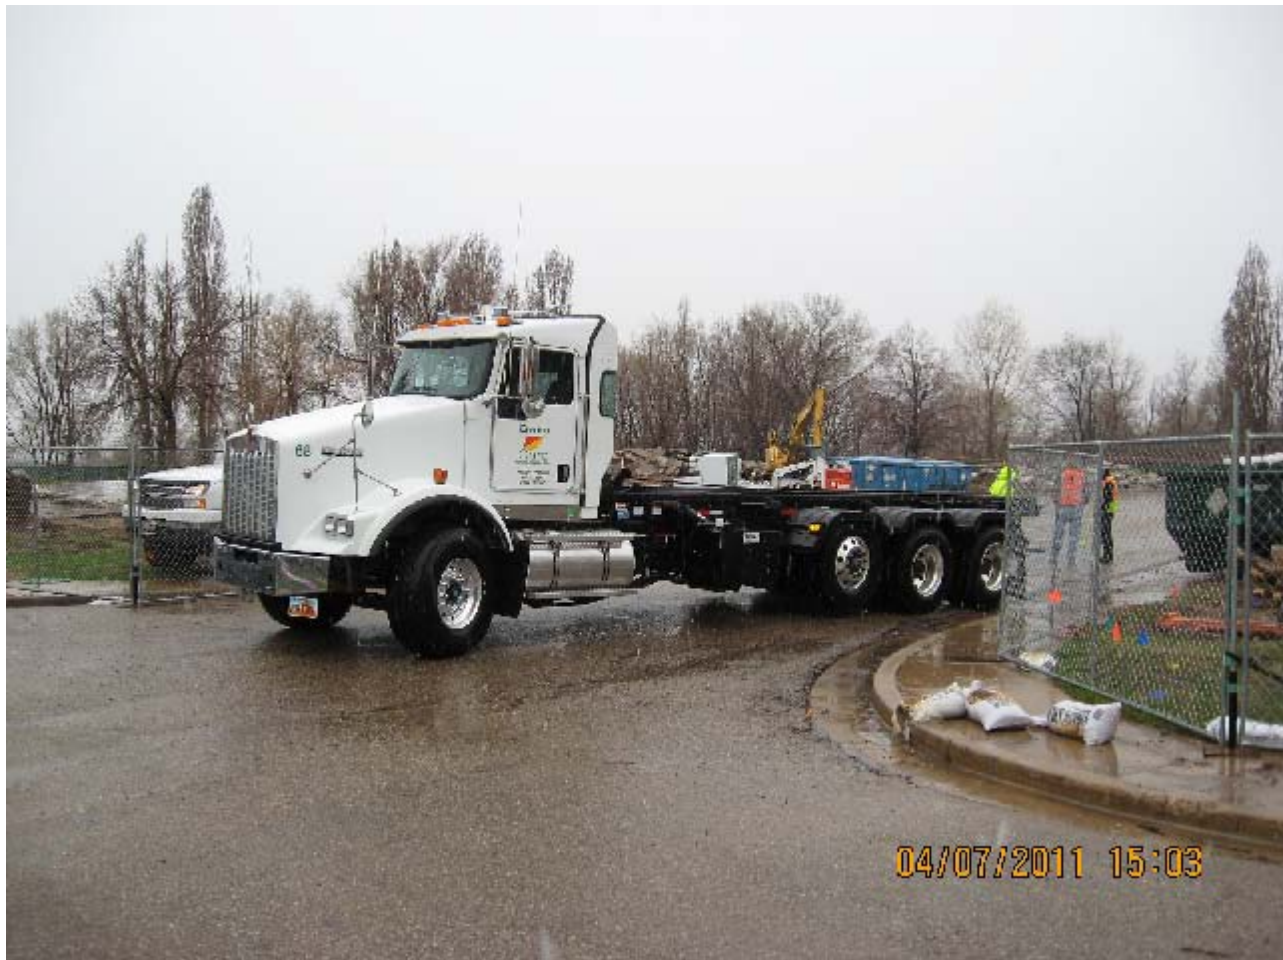
Date	Time	Direction of View
04-07-11	1503	W

Hill AFB Housing area OU-13. Enviro Care has re-staged the filled roll-off boxes at 4111 B North Bridge Circle.

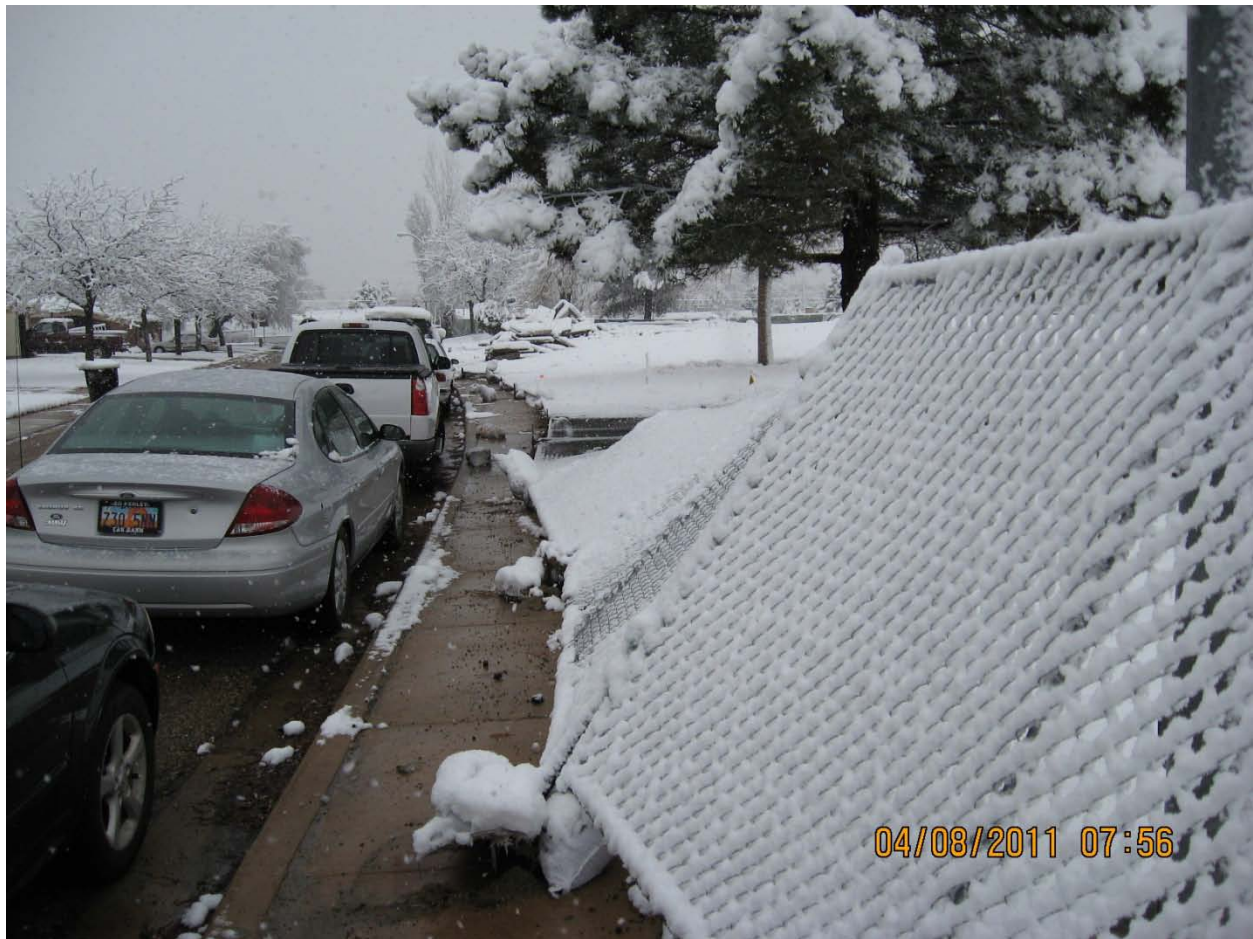
Date	Time	Direction of View
04-08-11	0756	SW

Hill AFB Housing area OU-13. Snow downed the fencing along Charleston Loop between 4114 Charleston Loop and North Bridge Circle. Housing contractor came out and repaired the fencing.

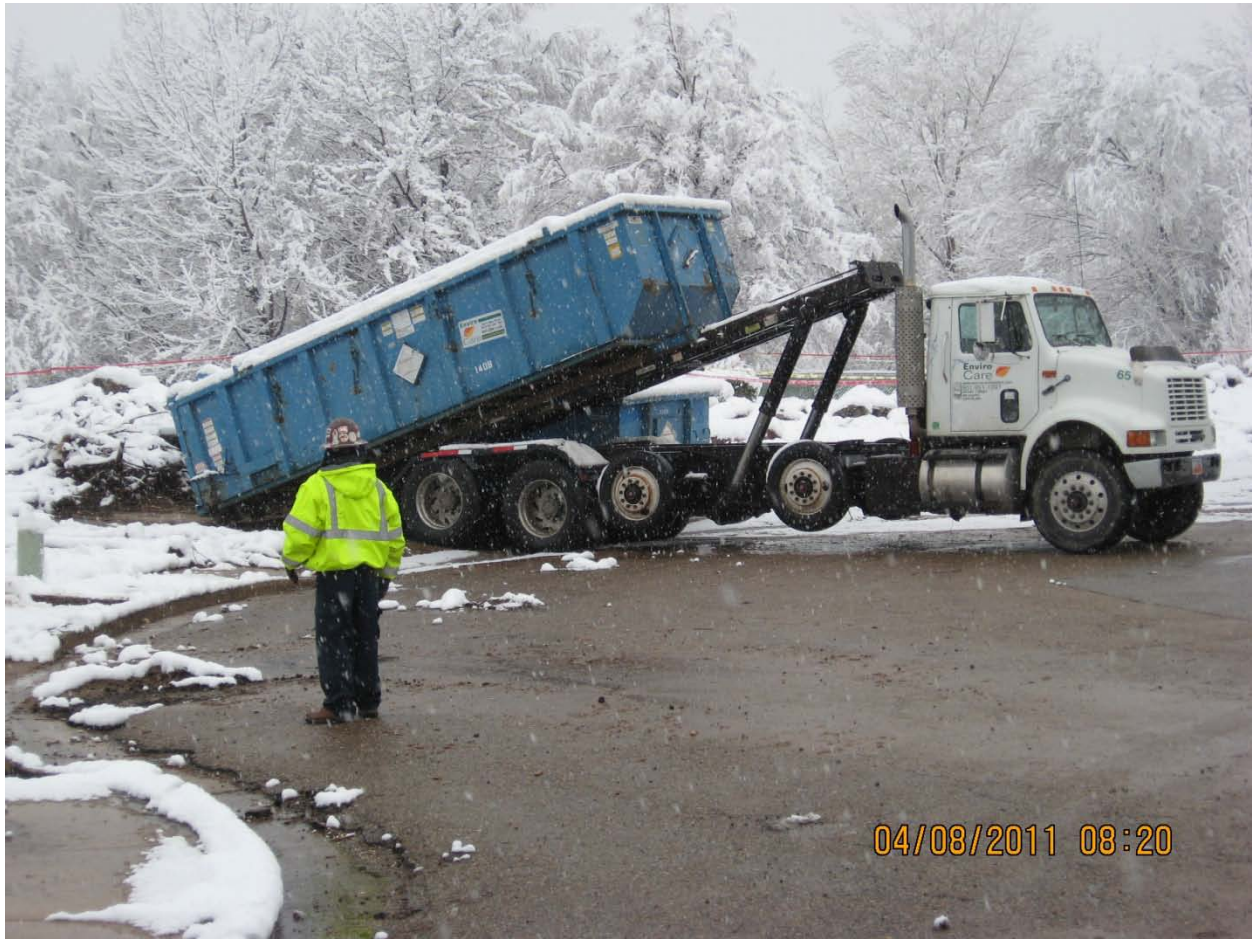
Date	Time	Direction of View
04-08-11	0820	W

Hill AFB Housing area OU-13. Loading up filled roll-off box No. 1 at 4111 B North Bridge Circle. This box was filled yesterday with TSCA regulated PCB contaminated soil.

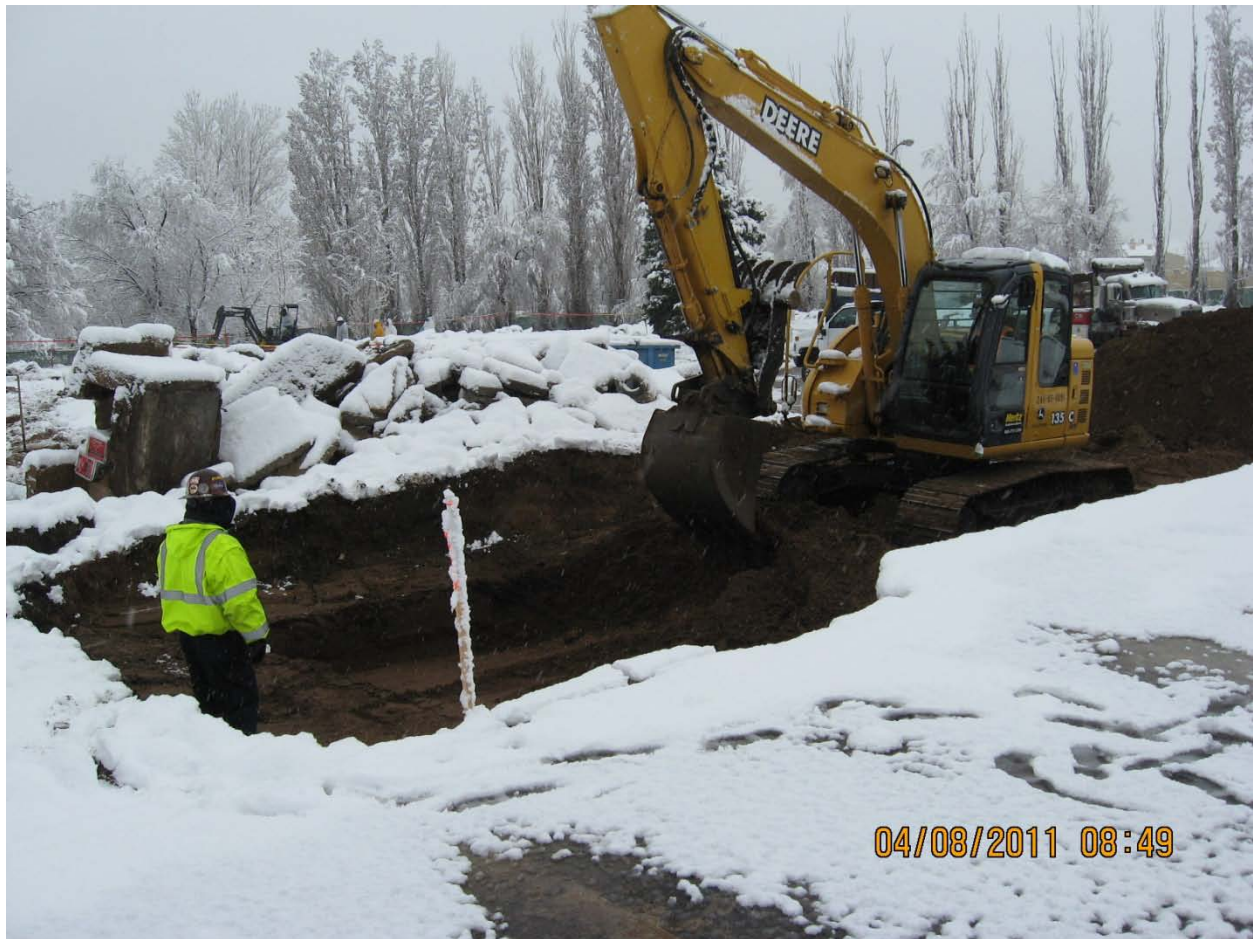
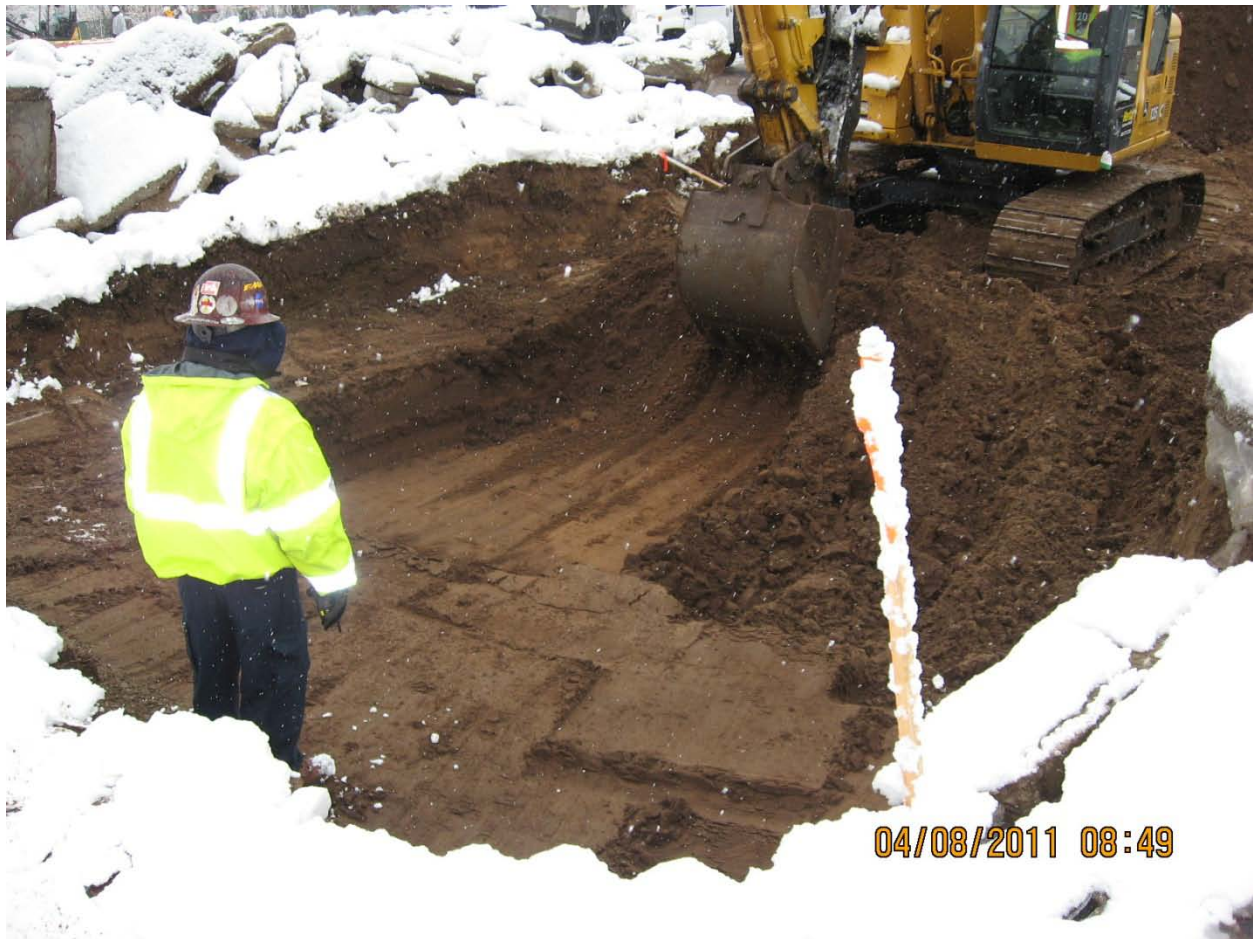
Date	Time	Direction of View
04-08-11	0849	NW

Hill AFB Housing area OU-13. Excavating to 4 ft depth to remove non-TSCA regulated fraction of soil at 4111 B North Bridge Circle.

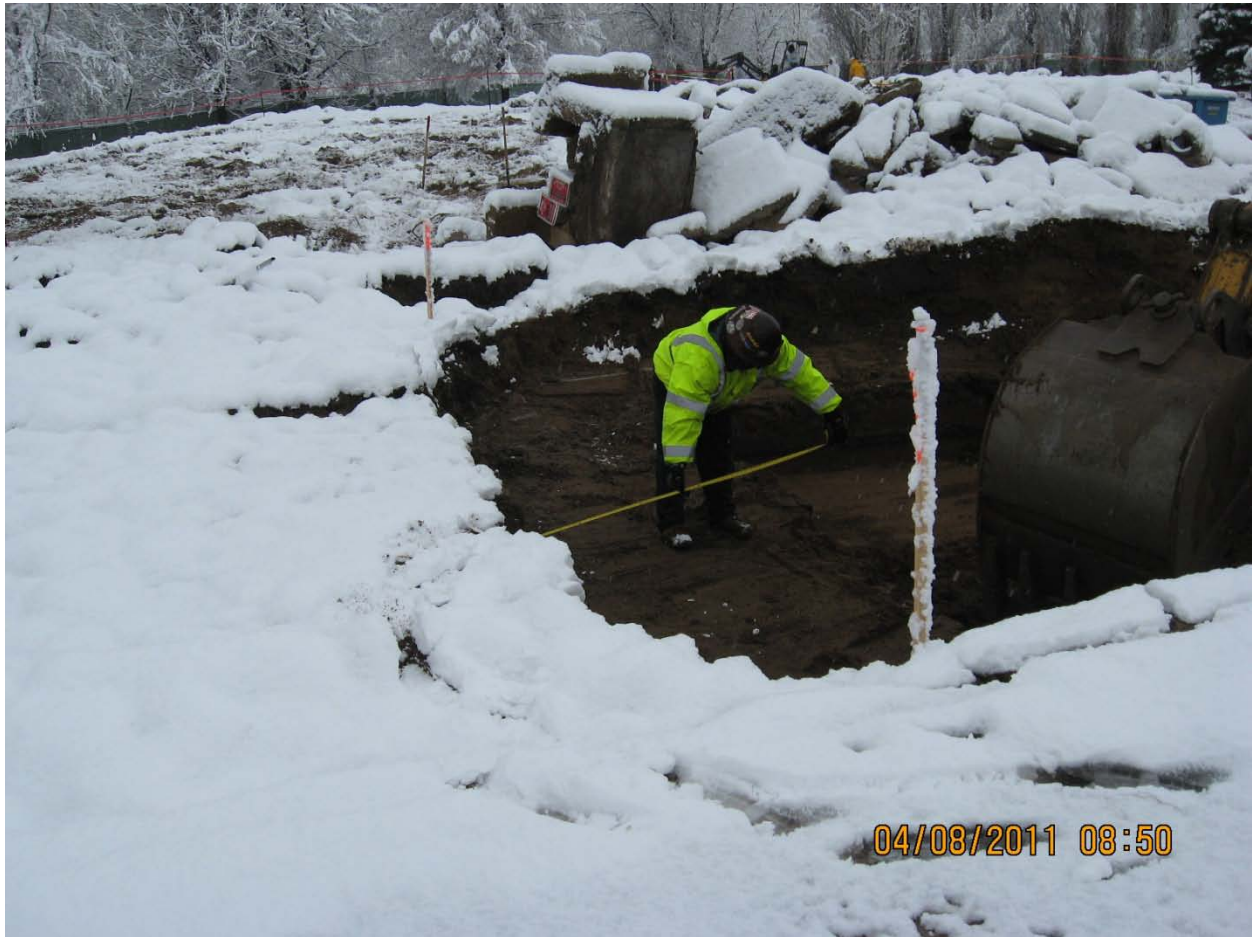
Date	Time	Direction of View
04-08-11	0850	NW

Hill AFB Housing area OU-13. Measuring dimensions of excavation at 4111 B North Bridge Circle.

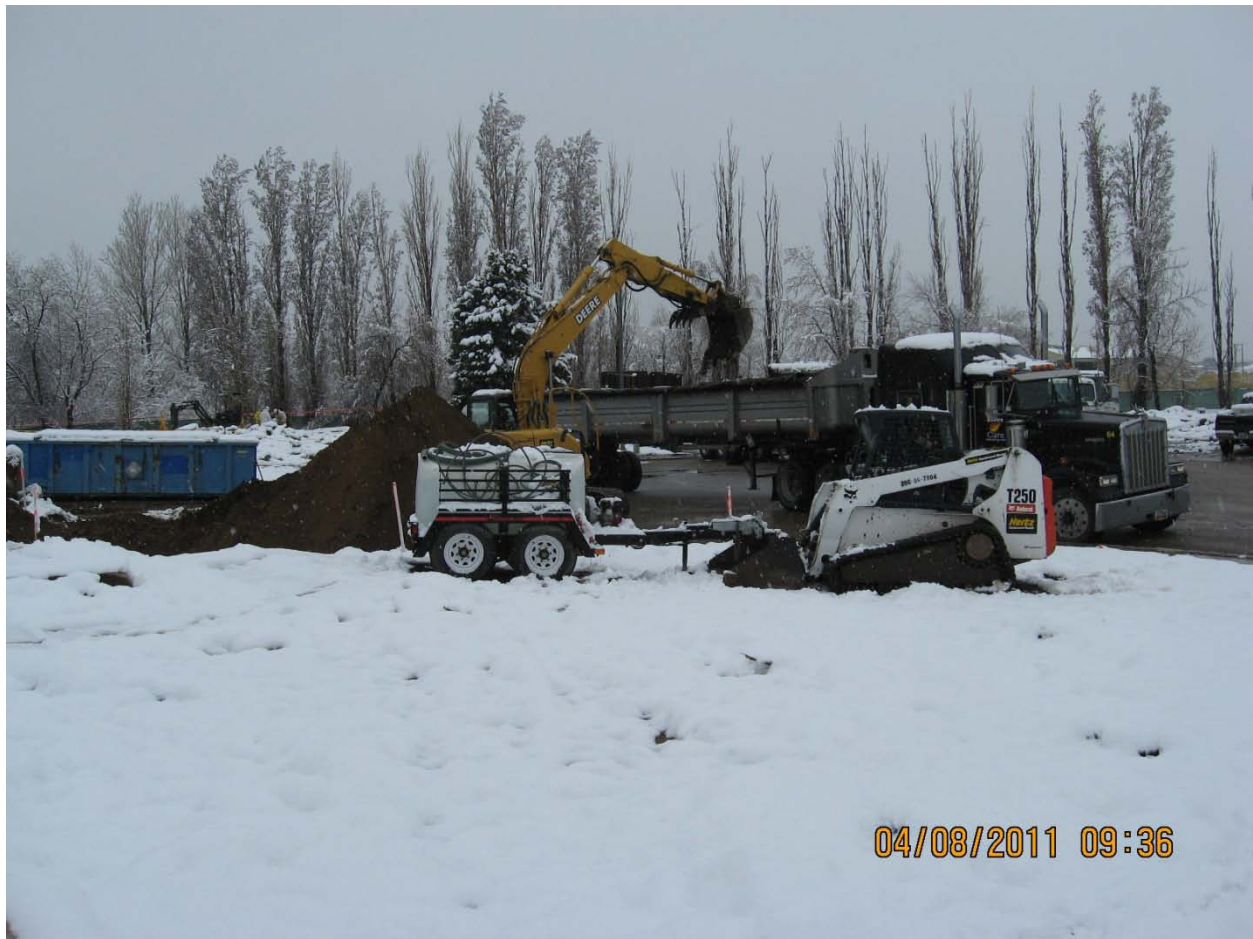
Date	Time	Direction of View
04-08-11	0936	NW

Hill AFB Housing area OU-13. Loading PCB contaminated (non TSCA) soil into the No. 1 20 cy end-dump at 4111 B North Bridge Circle.

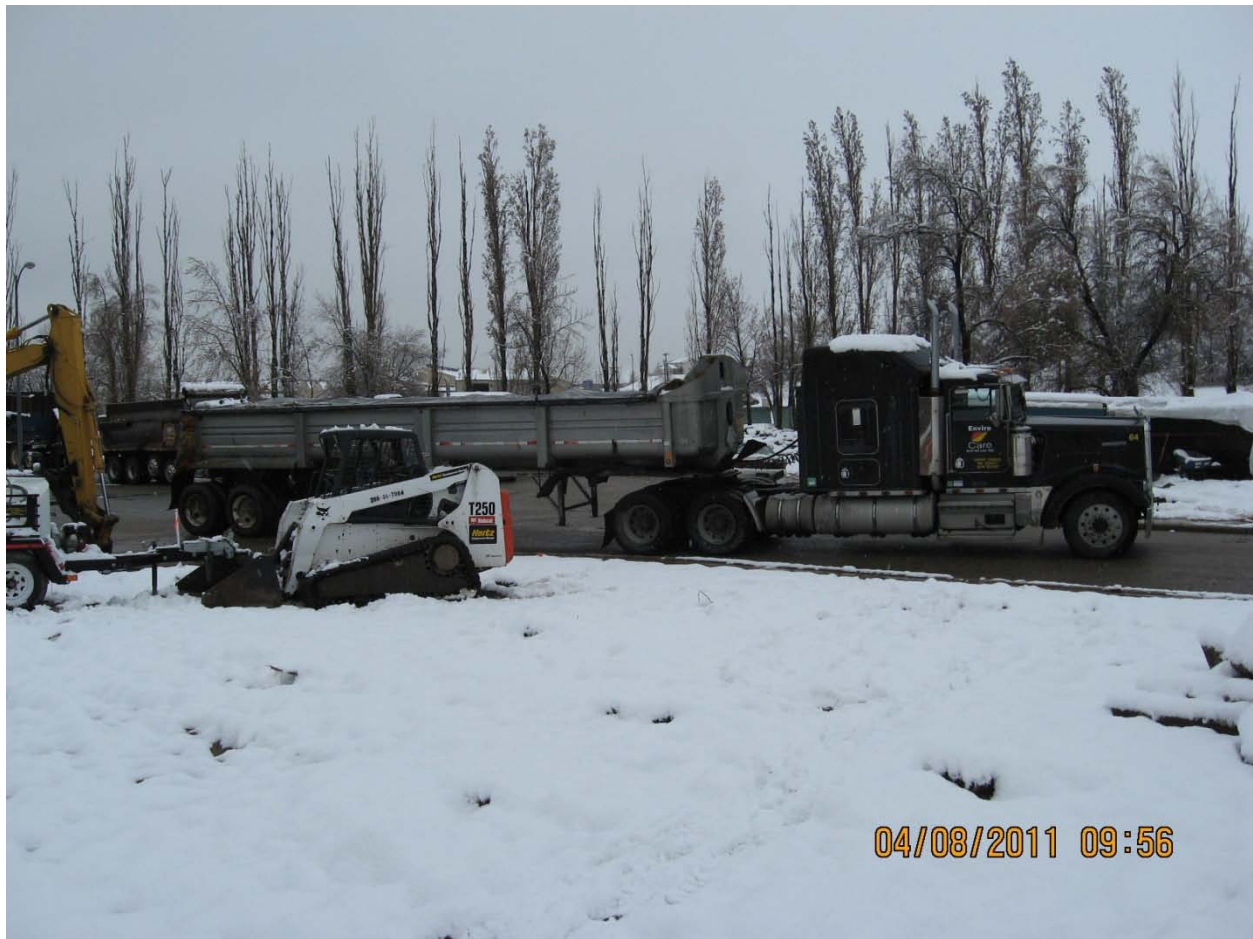
Date	Time	Direction of View
04-08-11	0956	NW

Hill AFB Housing area OU-13. No. 1 20 cy end-dump filled with PCB contaminated soil and covered at 4111 B North Bridge Circle.

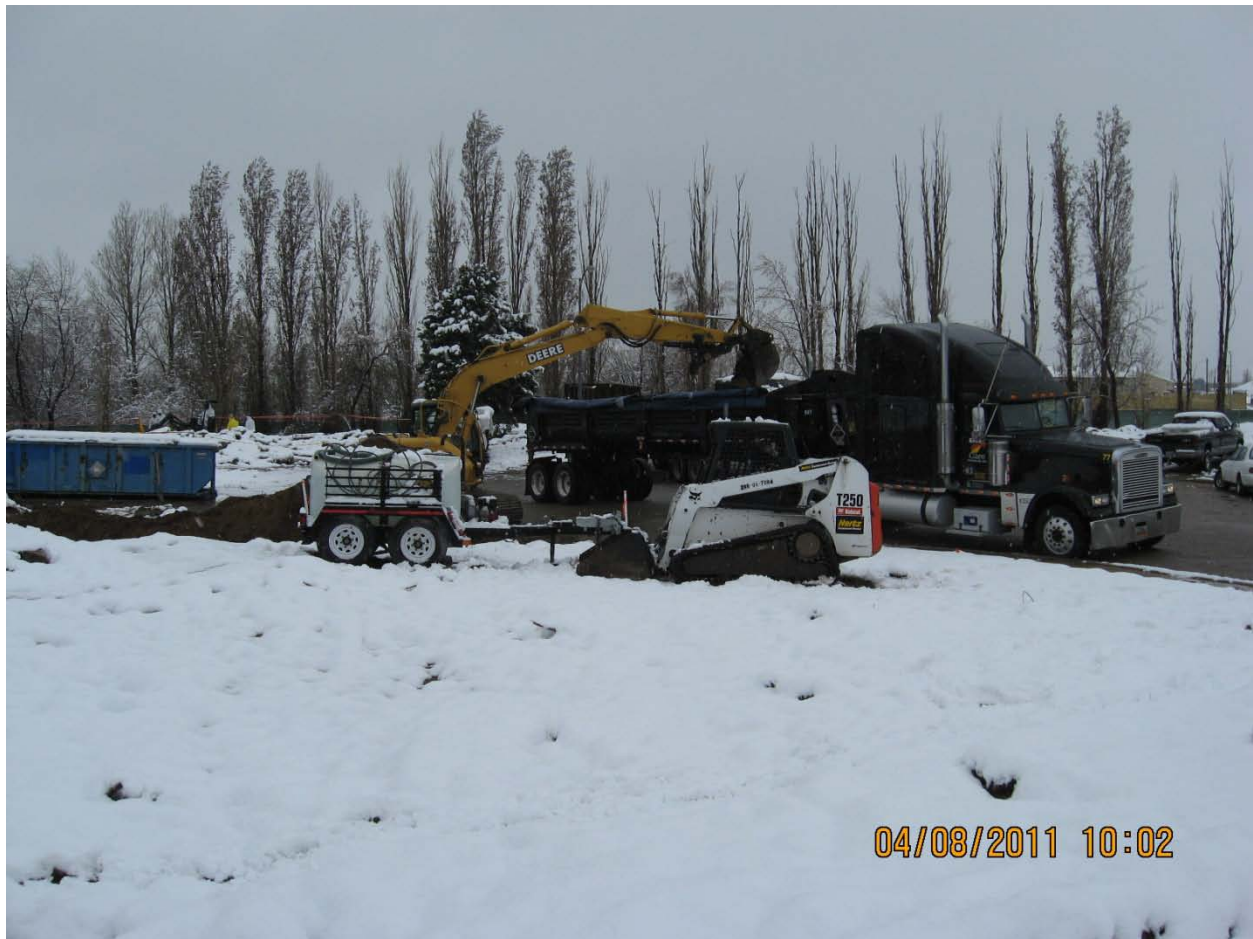
Date	Time	Direction of View
04-08-11	1002	NW

Hill AFB Housing area OU-13. Loading 20 cy end-dump No. 2 at 4111 B North Bridge Circle.

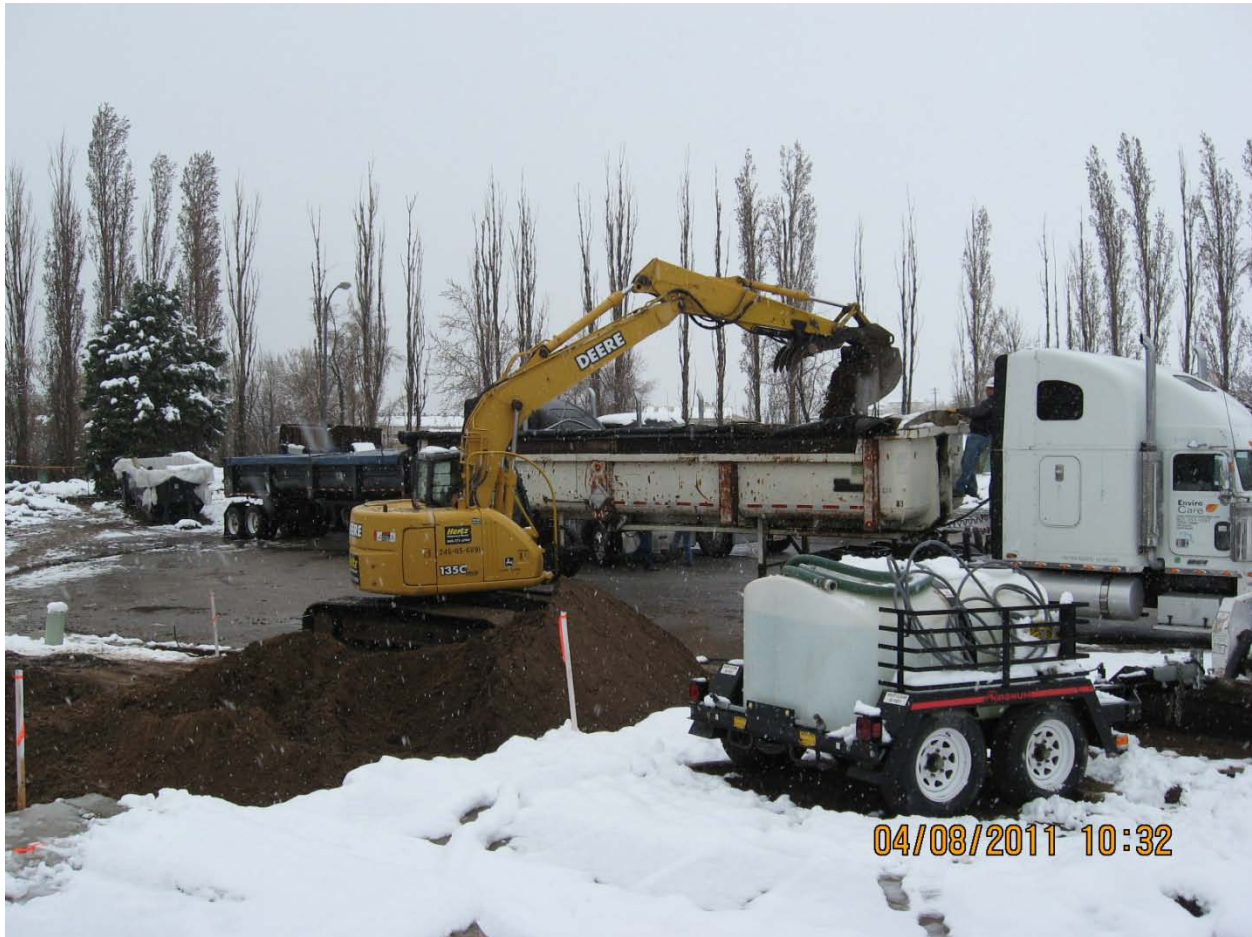
Date	Time	Direction of View
04-08-11	1032	NW

Hill AFB Housing area OU-13. Loading No. 3 end-dump with PCB contaminated soil at 4111 B North Bridge Circle.

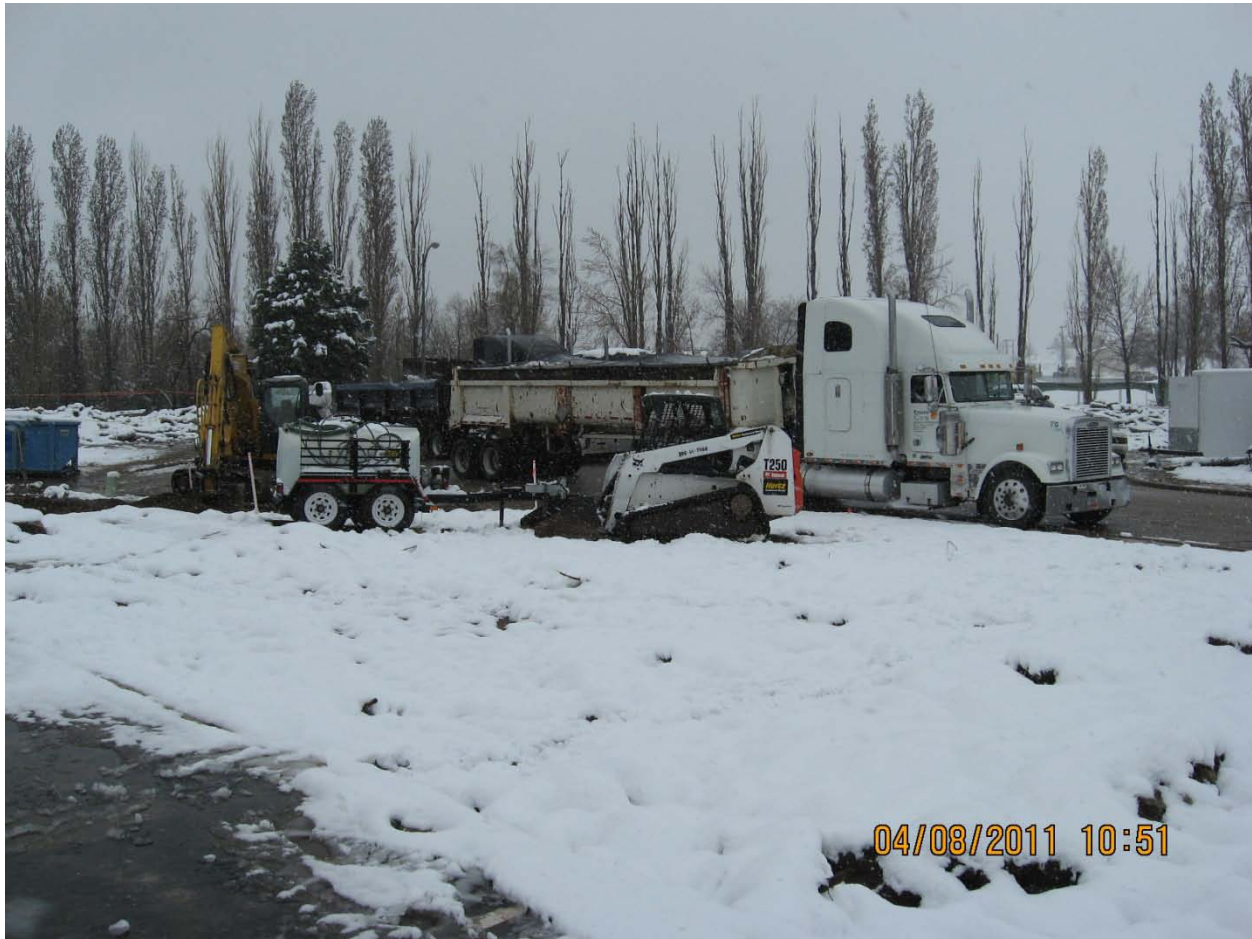
Date	Time	Direction of View
04-08-11	1051	NW

Hill AFB Housing area OU-13. No. 3 end-dump loaded with PCB contaminated soil and covered at 4111 B North Bridge Circle.
